ABOUT THE COVER

by Nancy A. Norling, DDS, AACD Accredited Member (AAACD)
and Lance A. Hancock

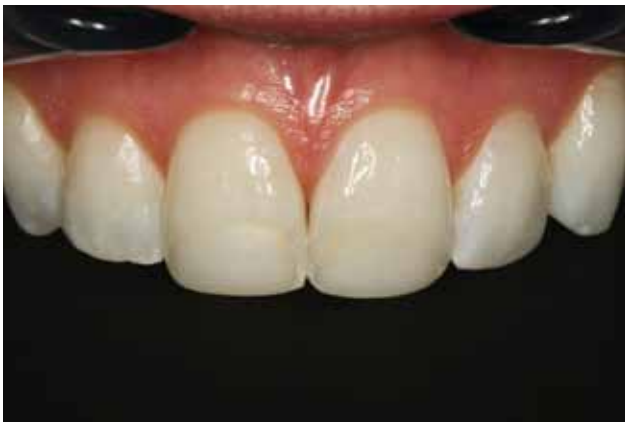
Years ago, Heather's two central incisors had been bonded to conceal two large enamel defects that left her teeth with large pitted and discolored concavities. The bonding had been replaced many times and the staining was becoming visible once again. Because she wanted a more permanent solution, one that would also make her teeth "fuller and more even," Lance strongly suggested restoring her teeth with porcelain veneers. However, Heather was concerned about losing tooth structure and that the new teeth would appear unnatural.

Preoperative.

Our goal in restoring a smile is to be as conservative as possible and achieve the desired results with as minimal reduction as possible. Although we were unable to correct Heather's left-of-center midline position, we did correct the slight cant, making the centrals more symmetrical. Teeth #4, #5, #12, and #13 were restored with "prep-less" veneers; prior to the impression taking, the only alterations were made using a fine sandpaper disc over the height of contour on #5 and #12.

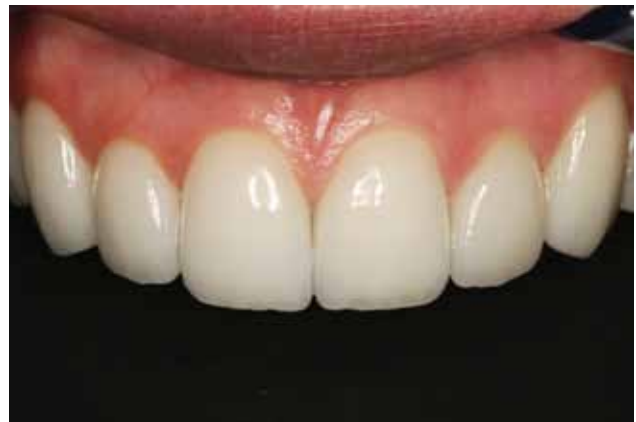
Postoperative.

Ten Empress veneers (Ivoclar Vivadent; Amherst, NY) were seated with little or no adjustment needed. The final result was a beautiful smile for an absolutely beautiful bride on her wedding day!
